SECTION 22
CONNECTICUT COASTAL STRUCTURES INVENTORY STUDY
PHASE II

APPENDIX J
BRANFORD QUADRANGLE

RECORDS OF STRUCTURES WITH PHOTOGRAPHS

JULY 1989

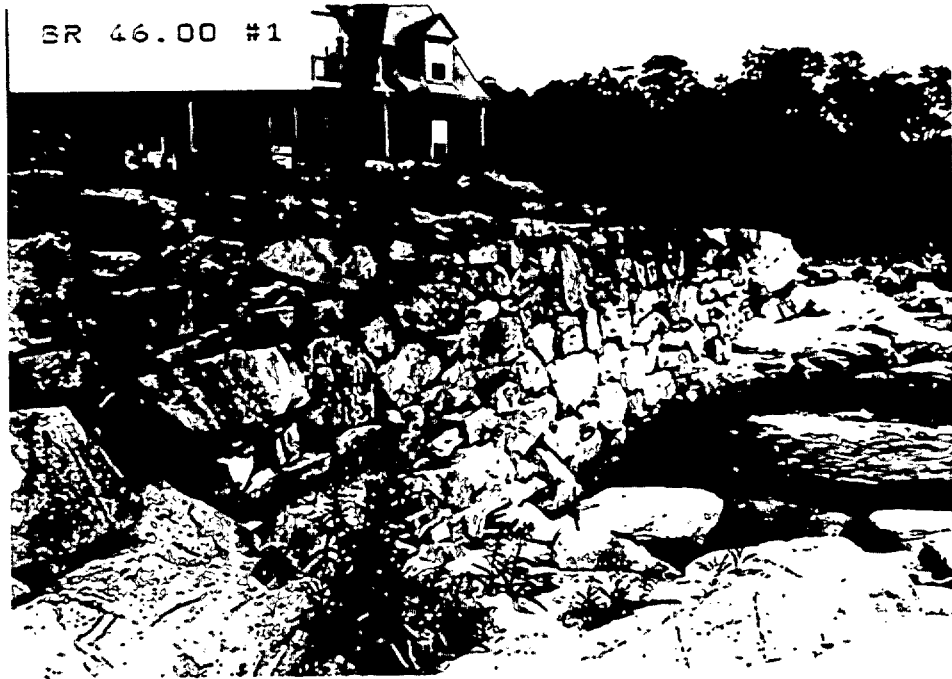
TYPE OF STRUCTURE: SEAWALL CONDITION: GOOD
MAIN FUNCTION : PREVENTS EROSION, RETAINS LAND
MATERIAL : STONE BLOCKS

SOME SAND, MARSH, AND EXPOSED BEDROCK

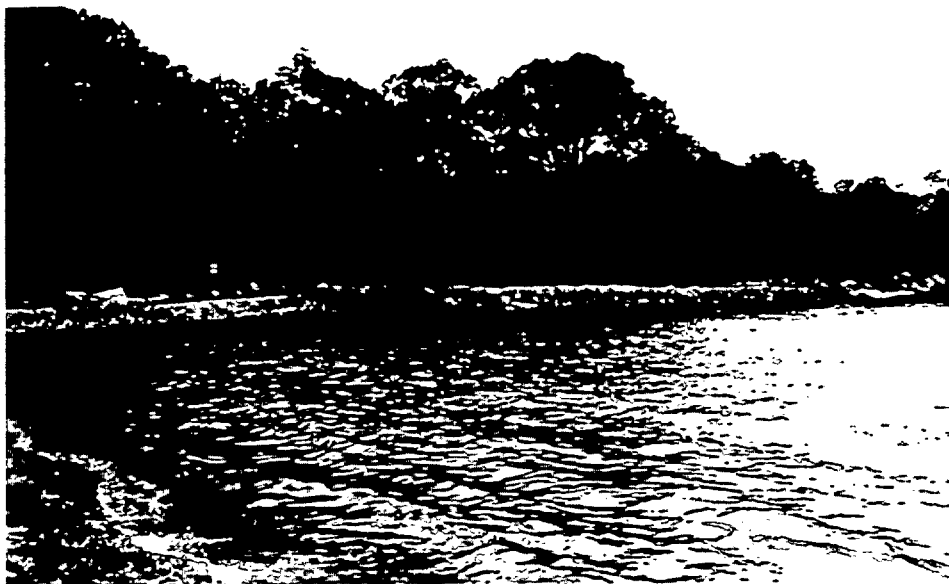
BR 47.00 #1

TYPE OF STRUCTURE: SEAWALL CONDITION: GOOD
MAIN FUNCTION : PREVENTS EROSION, RETAINS ROADWAY TO POINT
MATERIAL : STONE IN CEMENT

NO SHORE

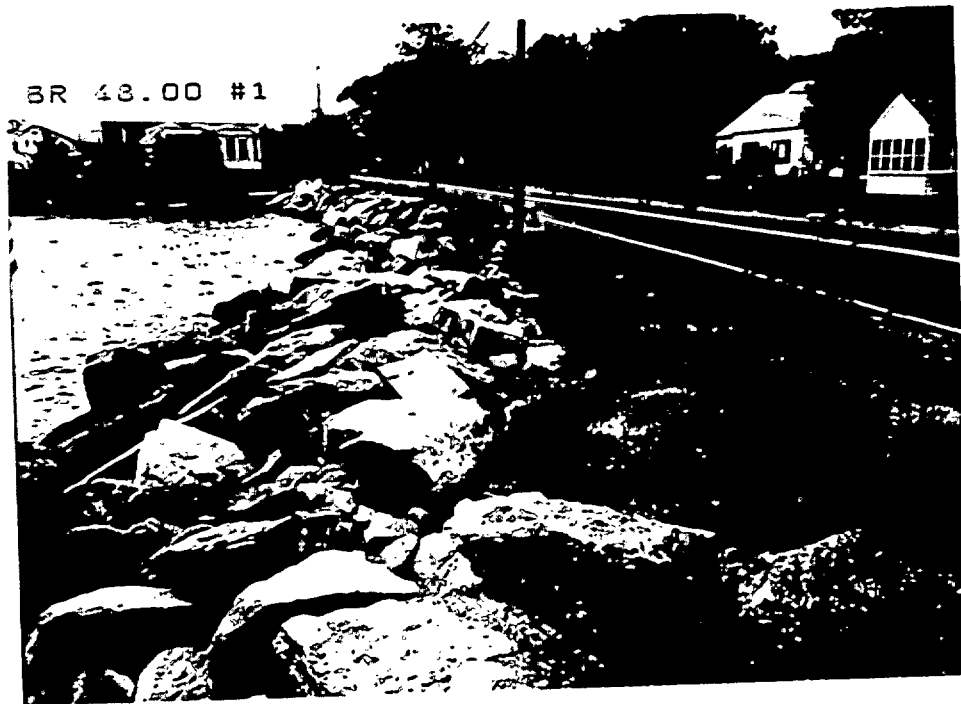
TYPE OF STRUCTURE: RIPRAP CONDITION: FAIR
MAIN FUNCTION : PROTECTIVE LAYER WHICH PREVENTS EROSION OF A ROAD
MATERIAL : STONE BLOCKS

SHORE: SAND, MARSH, AND EXPOSED BEDROCK

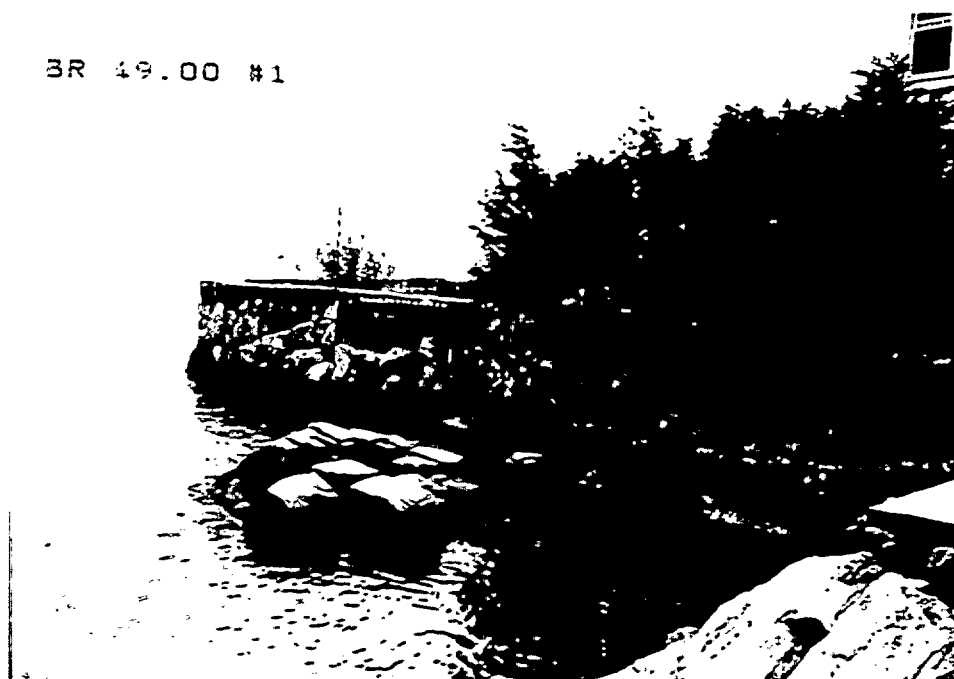
BR 49.00 #1

TYPE OF STRUCTURE: SEAWALL CONDITION: FAIR
MAIN FUNCTION : PREVENTS EROSION, RETAINS LAND
MATERIAL : STONE IN CEMENT

NO SHORE

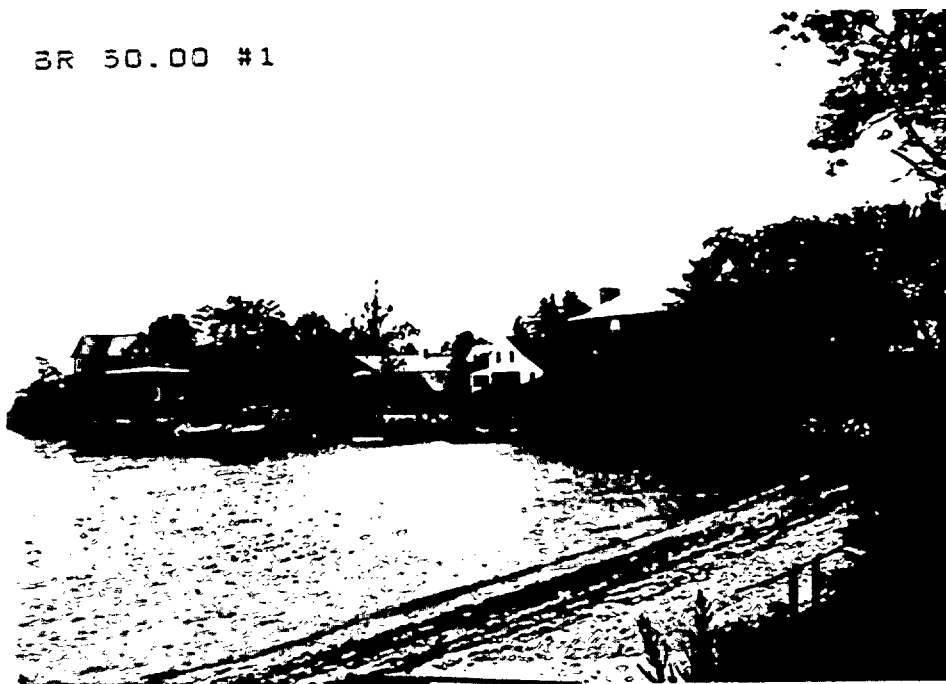
BR 50.00 #1

TYPE OF STRUCTURE: SEAWALL CONDITION: FAIR
MAIN FUNCTION : PREVENTS EROSION AND FLOODING, RETAINS LAND
MATERIAL : STONE IN CEMENT

NO SHORE

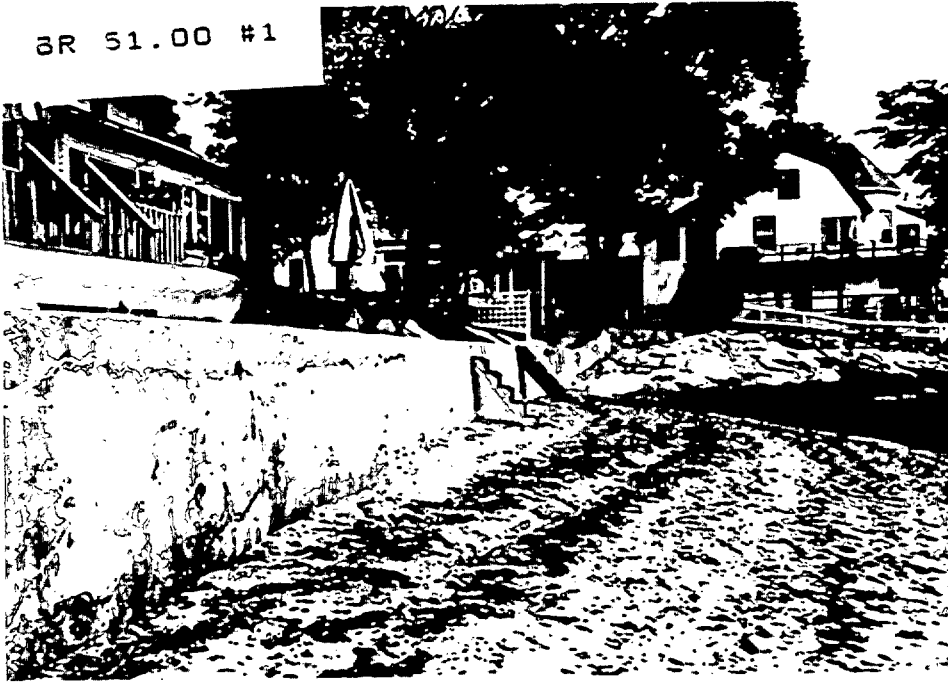
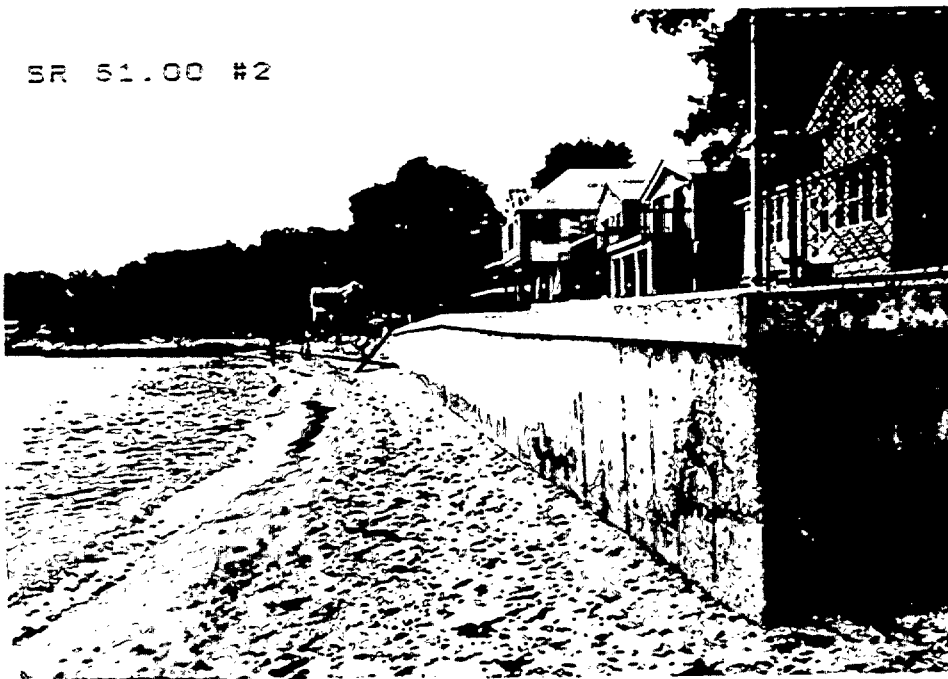
SR 51.00 #1

TYPE OF STRUCTURE: SEAWALL CONDITION: GOOD
MAIN FUNCTION : PREVENTS EROSION
MATERIAL : CONCRETE

SHORE: SANDY BEACH

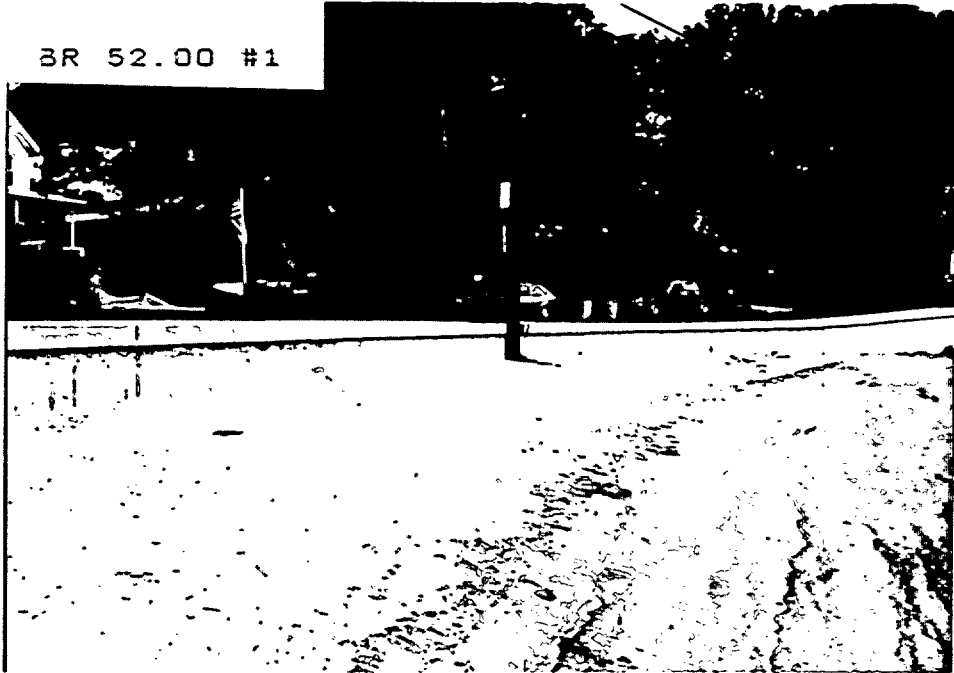
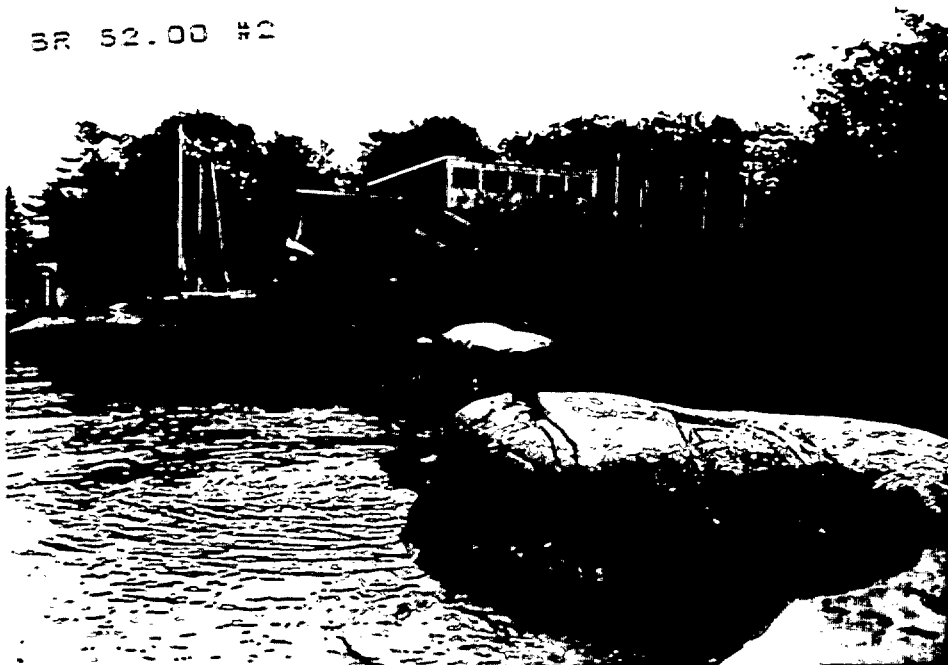
BR 52.00 #1

TYPE OF STRUCTURE: SEAWALL CONDITION: FAIR
MAIN FUNCTION : PREVENTS EROSION, RETAINS LAND
MATERIAL : STONE IN CEMENT

SHORE: SANDY BEACH

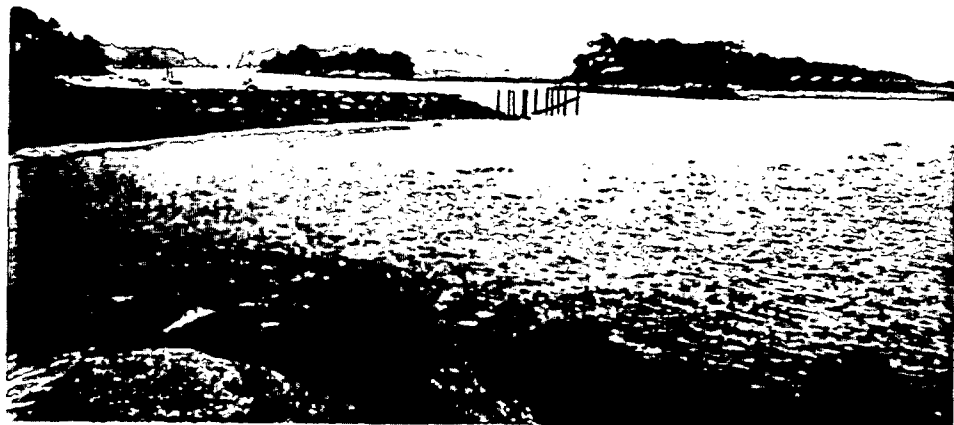
BR 34.00 #1

TYPE OF STRUCTURE: JETTY CONDITION: GOOD
MAIN FUNCTION : PREVENTS SHOALING OF CHANNEL
MATERIAL : LARGE BOULDERS

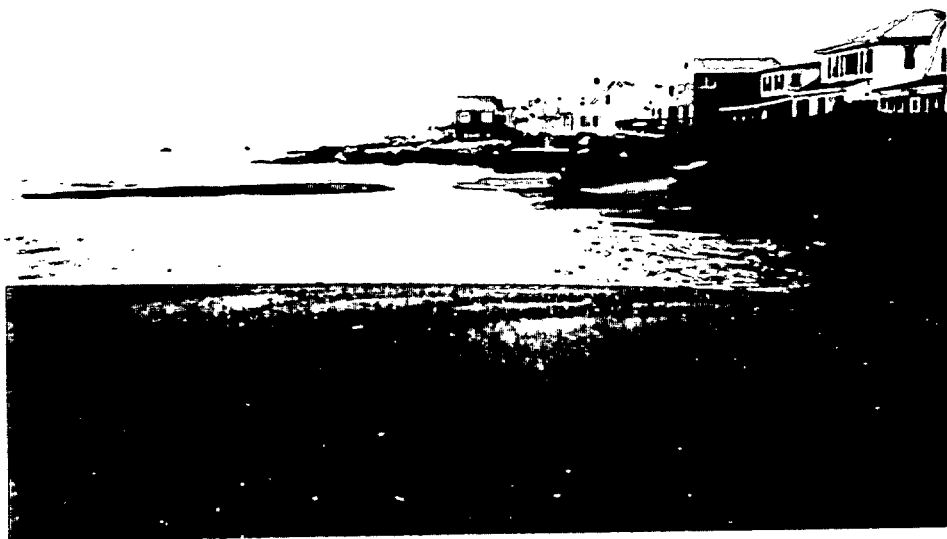
BR 65.00 #1

TYPE OF STRUCTURE: SEAWALL CONDITION: POOR
MAIN FUNCTION : SEPARATES LAND AND WATER, PREVENTS EROSION
MATERIAL : STONE IN CEMENT

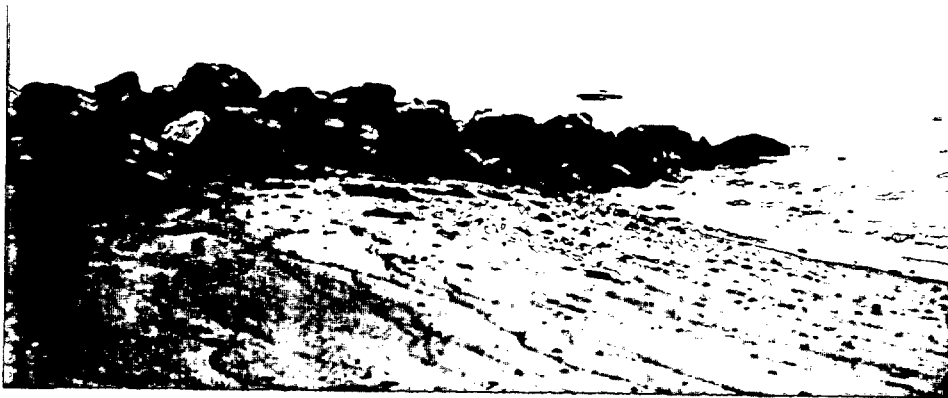
BR 36.30 #1

TYPE OF STRUCTURE: GROIN CONDITION: FAIR
MAIN FUNCTION : TRAPS LITTORAL DRIFT
MATERIAL : STONE BLOCKS

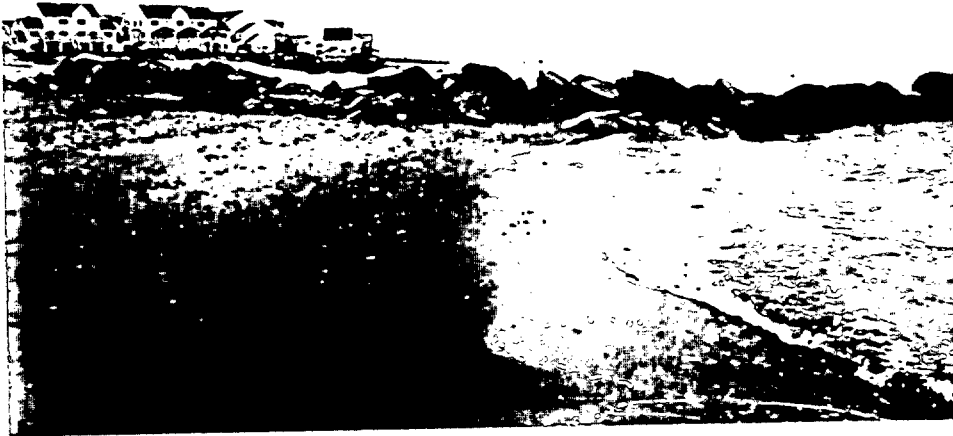
BR 57.00 #1

TYPE OF STRUCTURE: 3 GROINS CONDITION: FAIR
MAIN FUNCTION : TRAPS LITTORAL DRIFT
MATERIAL : STONE BLOCKS

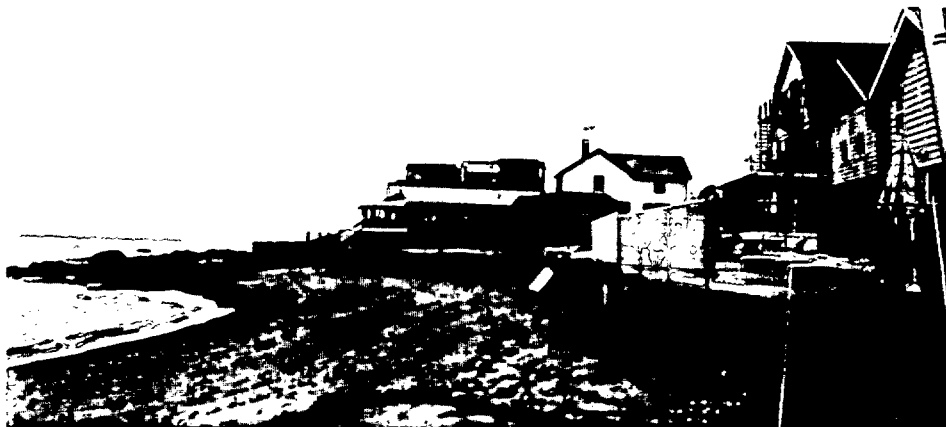
BR 58.00 #1

TYPE OF STRUCTURE: SEAWALL CONDITION: GOOD
MAIN FUNCTION : SEPARATES LAND AND WATER
MATERIAL : CONCRETE
